ASSESSOR'S REPORT

Assessment code: **72/0011/11**

Subject matter of the order: **Testing of open mesh flooring**
Determination of the failure load and deflection with a
point load

Description of sample: **Open mesh flooring of recycled plastic**
Nominal dimensions: 1000x500x80 mm

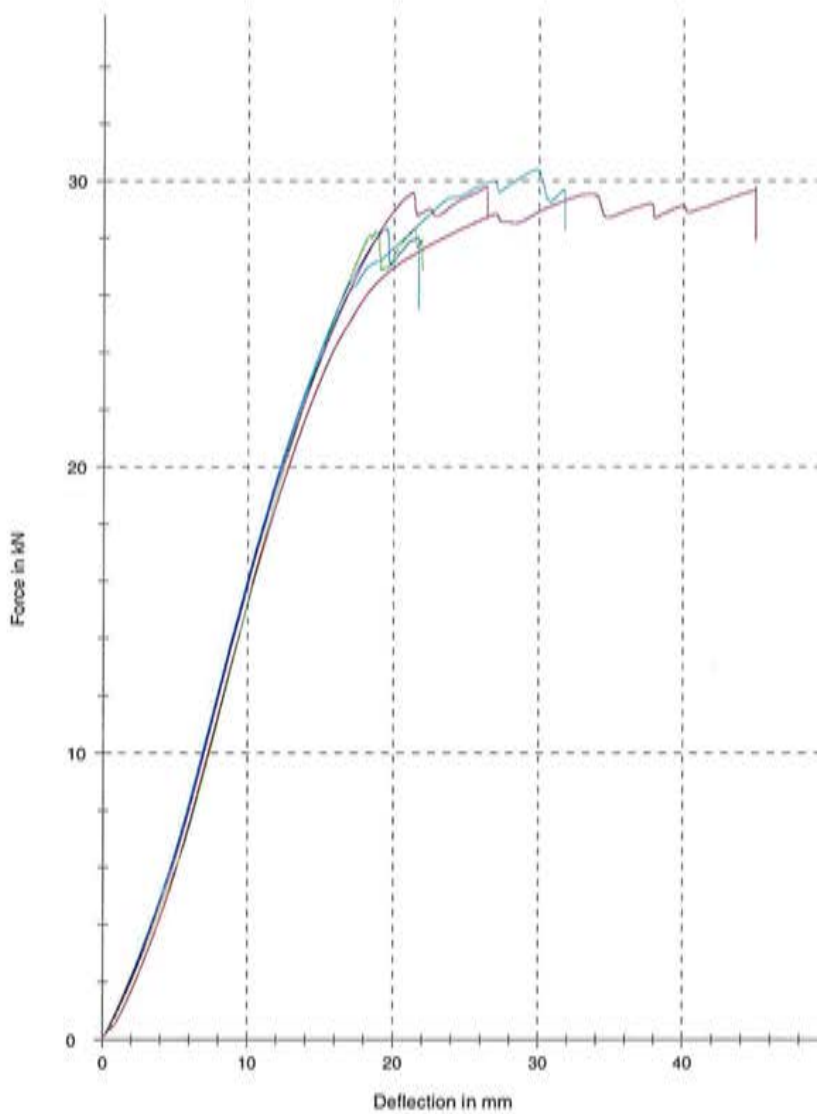
Figure 5: Force-displacement diagram for load case 1

Sample no.	Initial crack load	Deflection
	[kN]	[mm]
1	28.83	27.02
2	28.13	18.35
3	28.34	19.49
4	30.00	26.77
5	29.58	21.32
Mean	28.98	22.59

The test results are shown in Table 2, Table 3 and Table 4. The force-displacement diagrams for the tests can be found in Figure 4, Figure 6 and Figure 9.

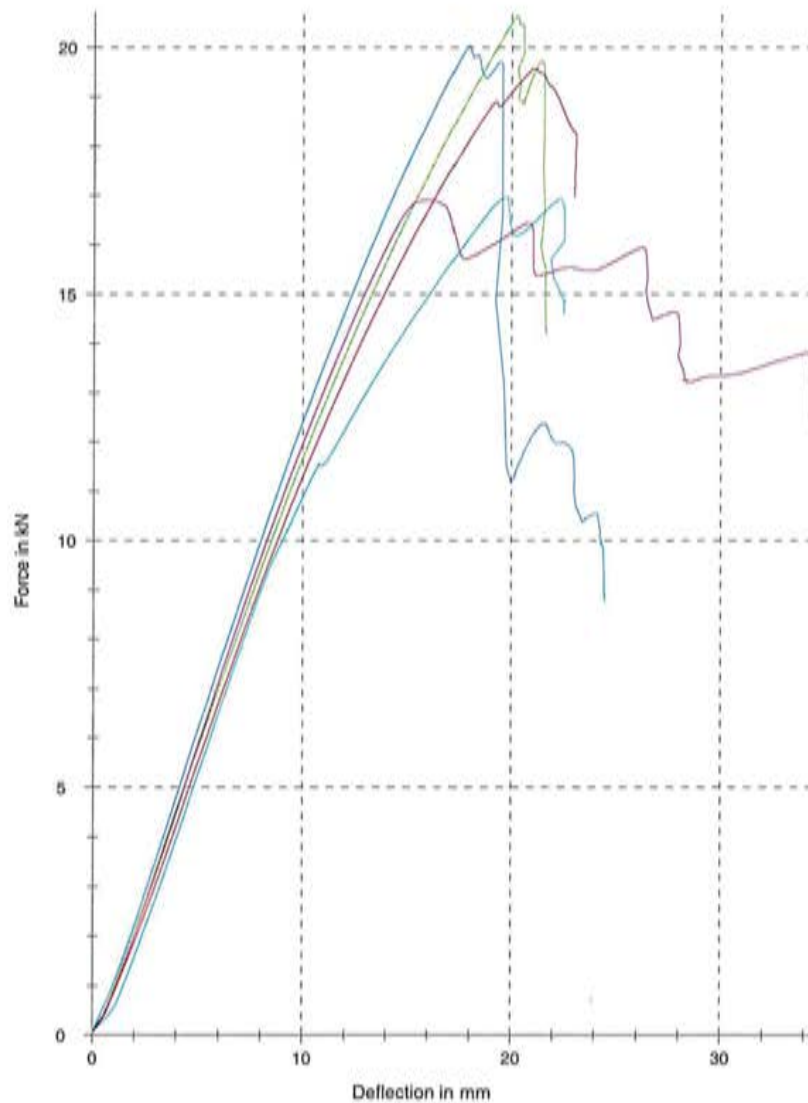
Figure 7: Force-displacement diagram for load case 2

Sample no.	Initial crack load	Deflection
	[kN]	[mm]
1	18.90	19.27
2	20.64	20.27
3	20.02	18.00
4	16.97	19.75
5	16.91	16.00
Mean	18.69	18.66
